RE: **HRS 6E-8 Historic Preservation Review**
Old Hilo Jail – Demolition
60 Punahale St. Hilo, HI 96720
Waiākea Ahupua‘a, Hilo District, Island of Hawai‘i
TMK: (3)-2-3-023:005

HISTORIC AMERICAN BUILDINGS SURVEY

HILO JAIL
(Old Hilo Jail)
(South Hilo Jail)
(Hilo Community Correctional Center Administration Building)
60 Punahale Street
Hilo
Hawaii County
Hawaii

HABS No. HI-598

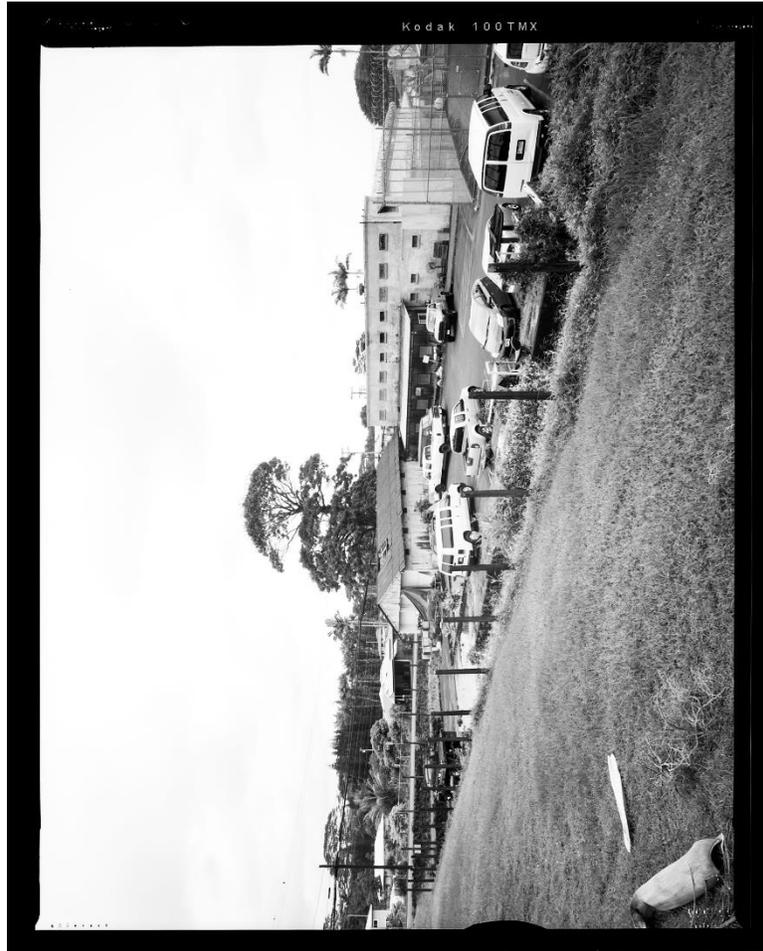
HABS No. HI-598-1

| HI-598-1 | Overview of Hilo Jail from southwest side of property. View facing north. |

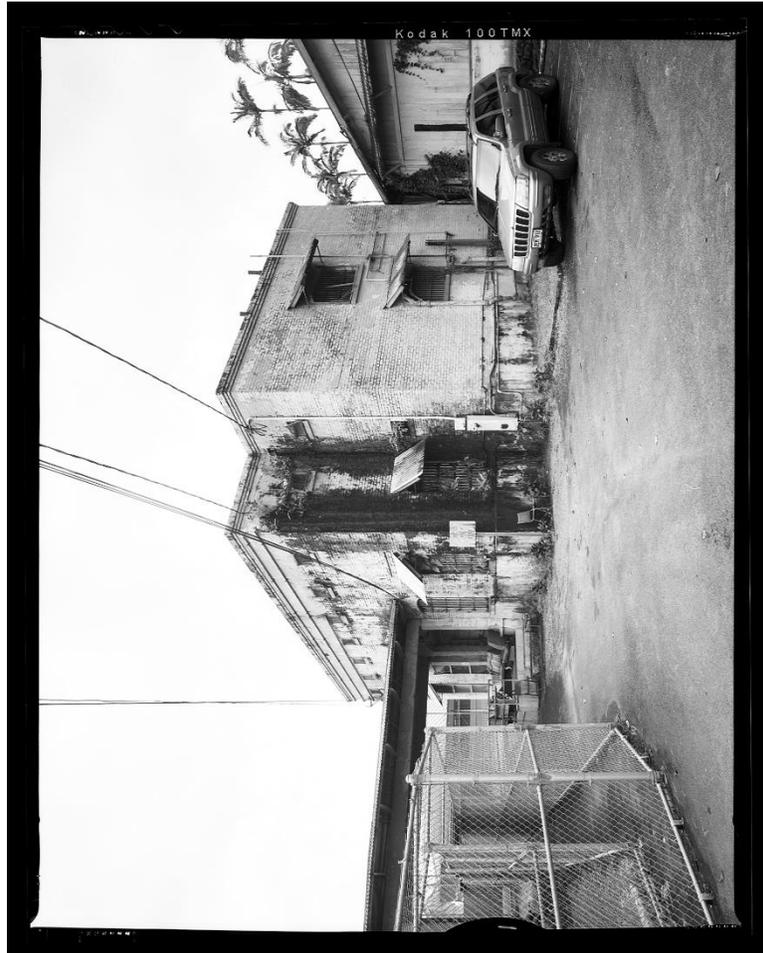
HABS No. HI-598-2

| HI-598-2 | Oblique of northeast and northwest sides. View facing south. |

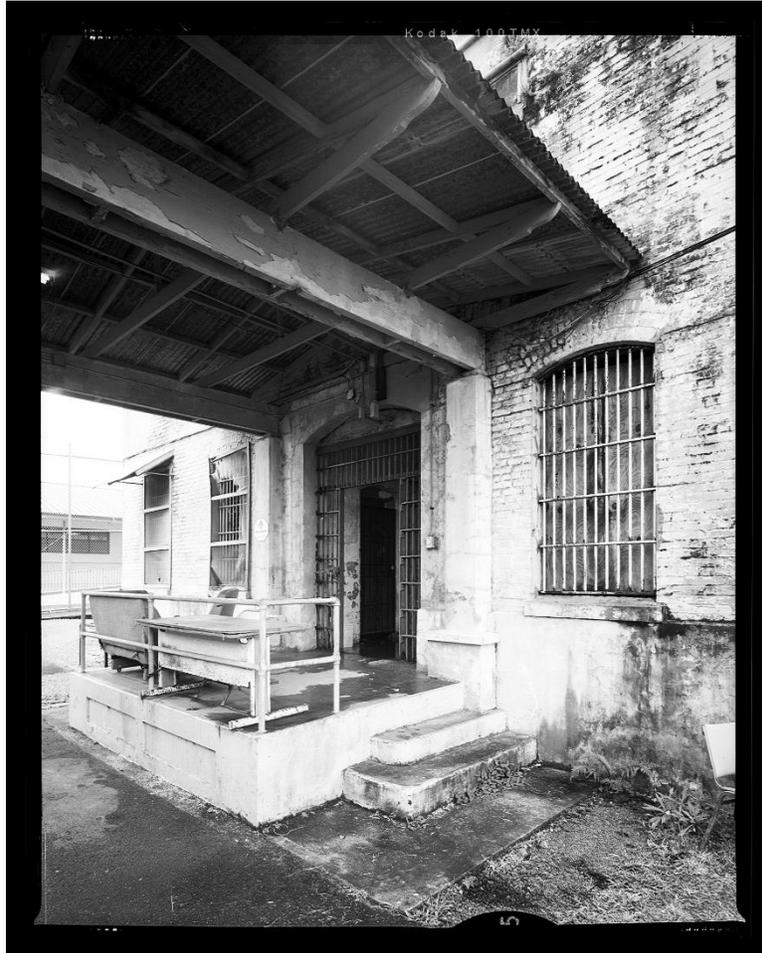
HABS No. HI-598-3

| HI-598-3 | Front entrance area. View facing south. |

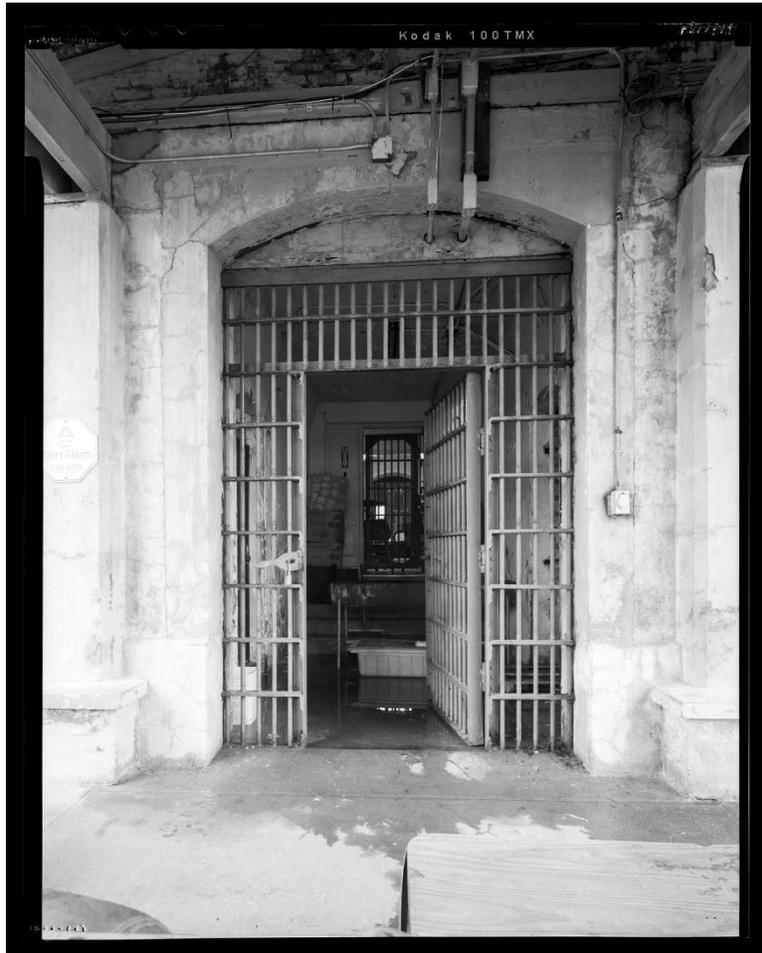
HABS No. HI-598-4

| HI-598-4 | Main front door showing passage to interior and rear entry door. View facing southwest. |

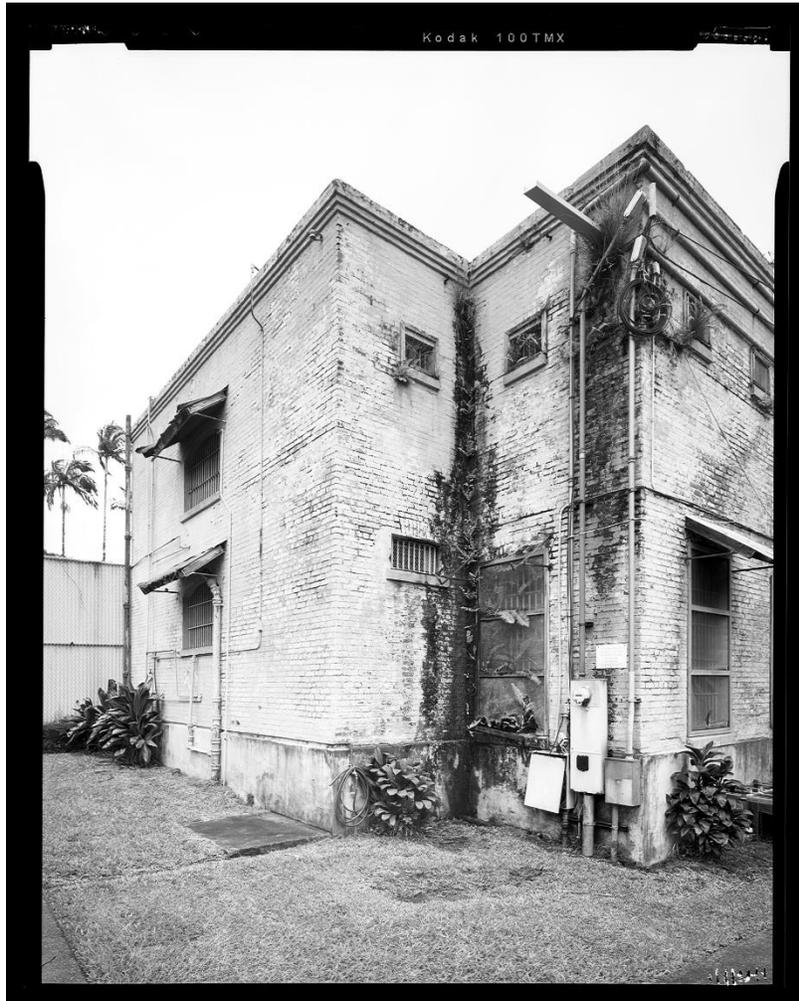
HABS No. HI-598-5

| HI-598-5 | Oblique of southeast side. View facing west. |

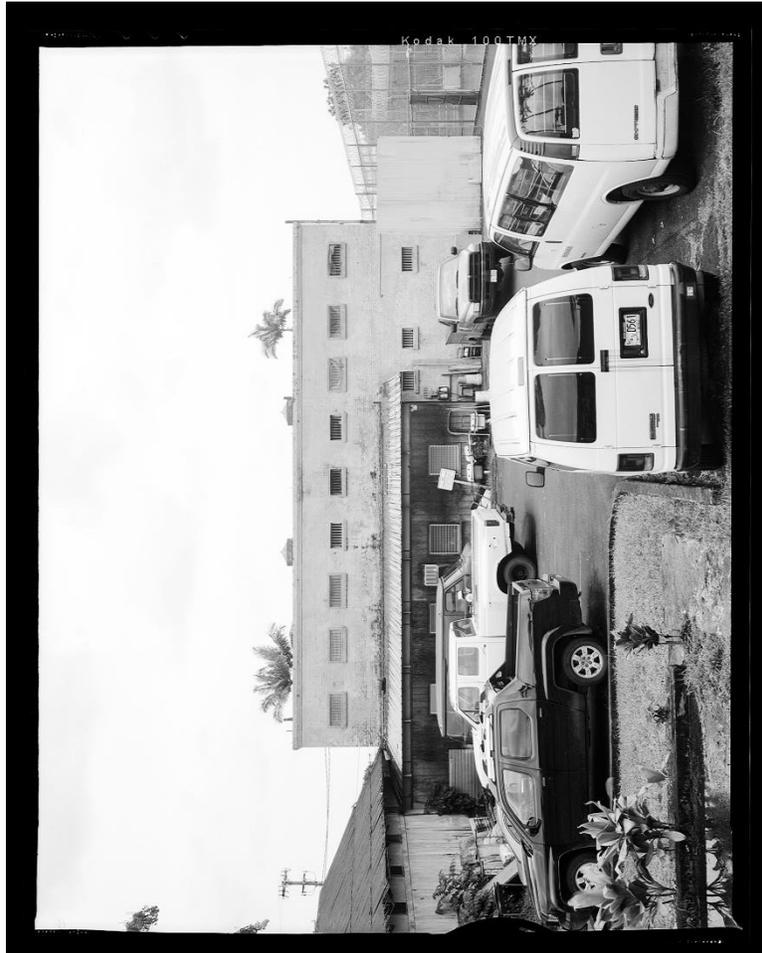
HABS No. HI-598-6

| HI-598-6 | Rear elevation. View facing west-northeast. |

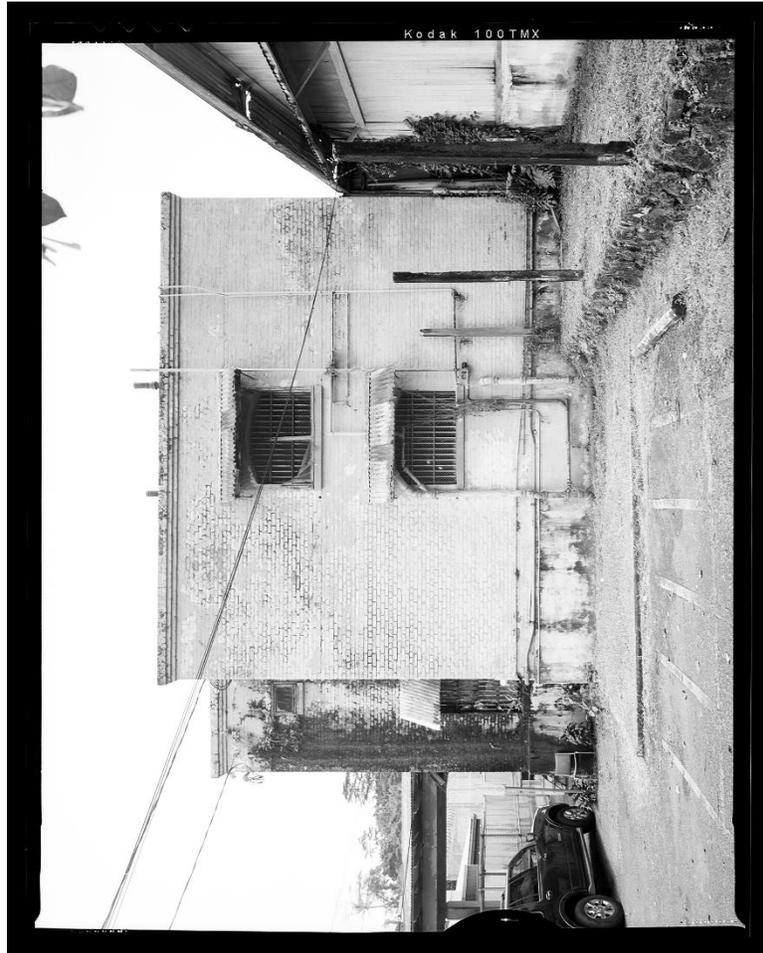
HABS No. HI-598-7

| HI-598-7 | Elevation of northwest side. View facing southeast. |

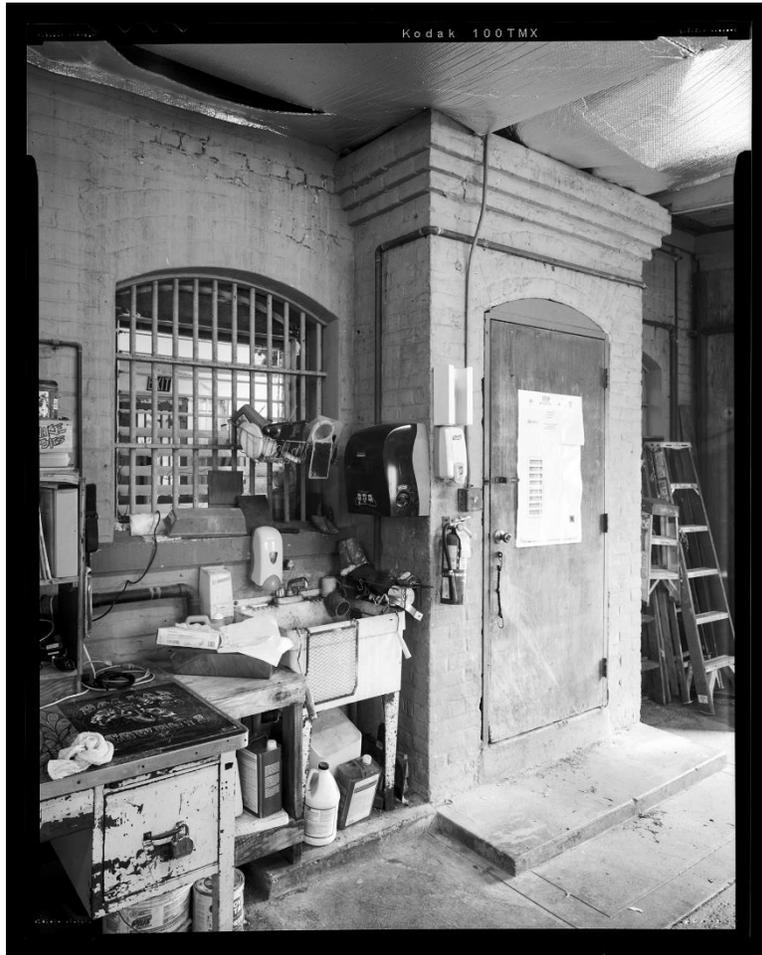
HABS No. HI-598-8

| HI-598-8 | Detail of rear entry (inside shed addition). View facing east. |

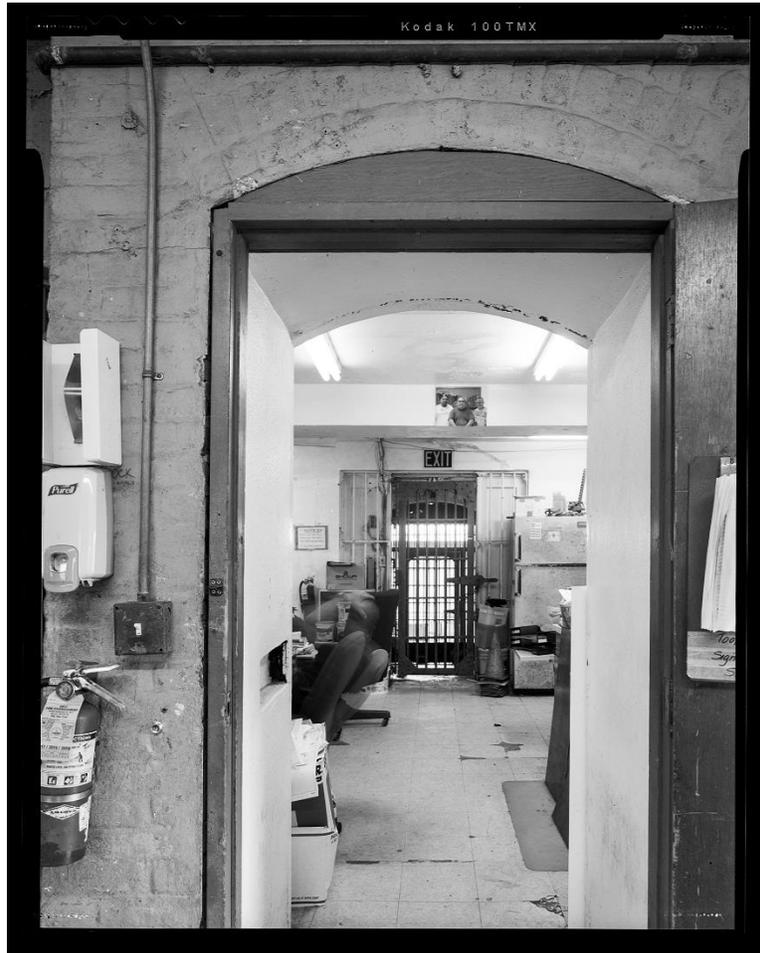
HABS No. HI-598-9

| HI-598-9 | Rear entry looking through interior to front entry. View facing northeast. |

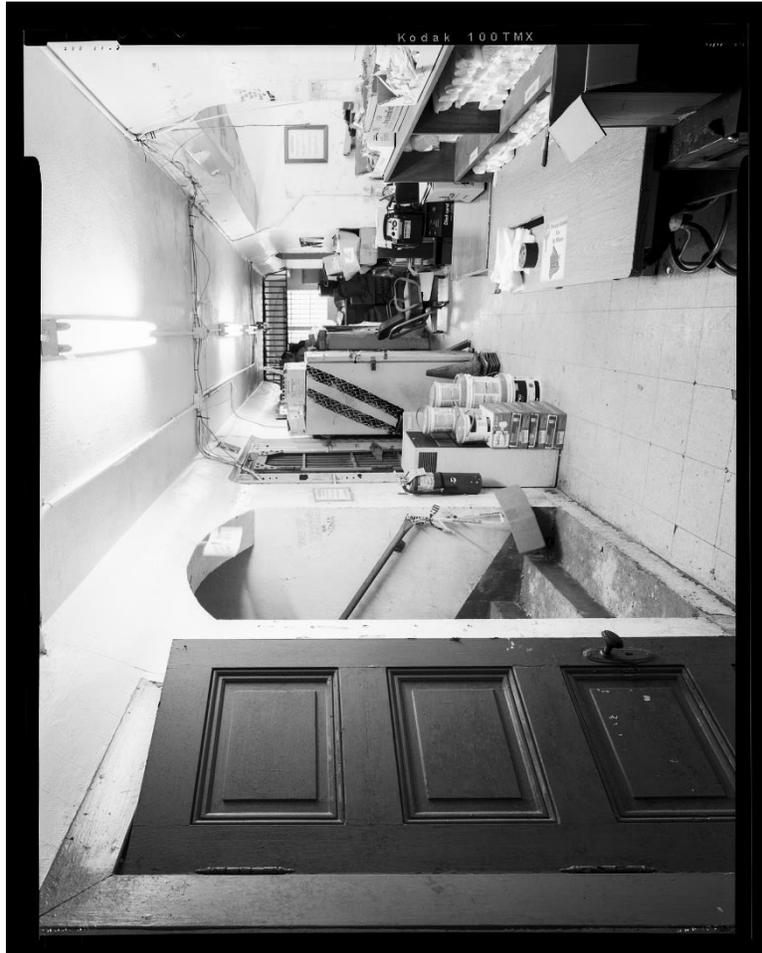
HABS No. HI-598-10

| HI-598-10 | First floor hallway showing entrance to stairway at left. View facing east. |

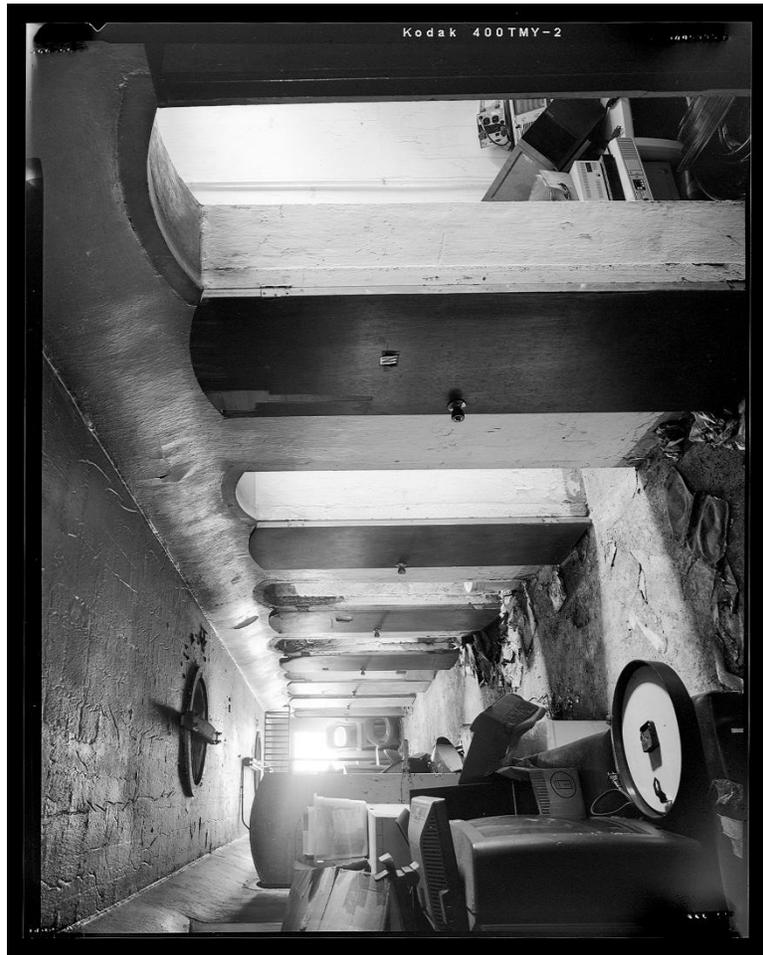
HABS No. HI-598-11

| HI-598-11 | Second floor hallway showing cell doors at right. View facing south. |

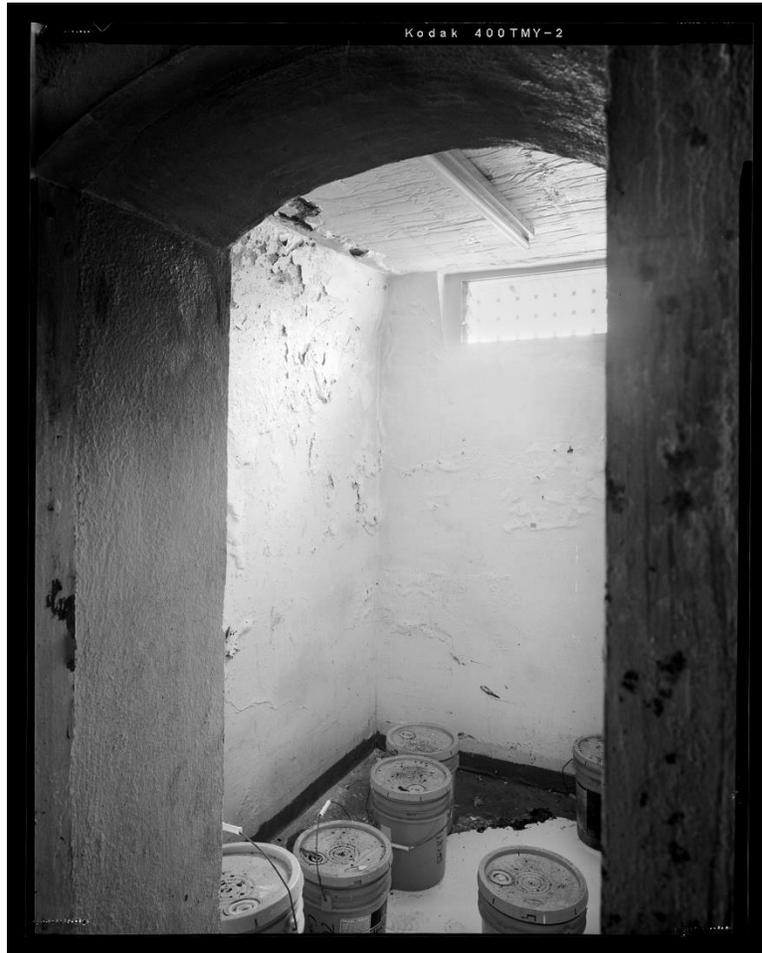
HABS No. HI-598-12

| HI-598-12 | Second floor cell. View facing south. |

after this time. As of 2018, the brick jail building, wood cell annex and shed addition were used for maintenance activities and storage. The second floor of the brick building had been damaged by a fire in 2017 that scorched the walls and ceiling, and destroyed ceiling-hung light fixtures.

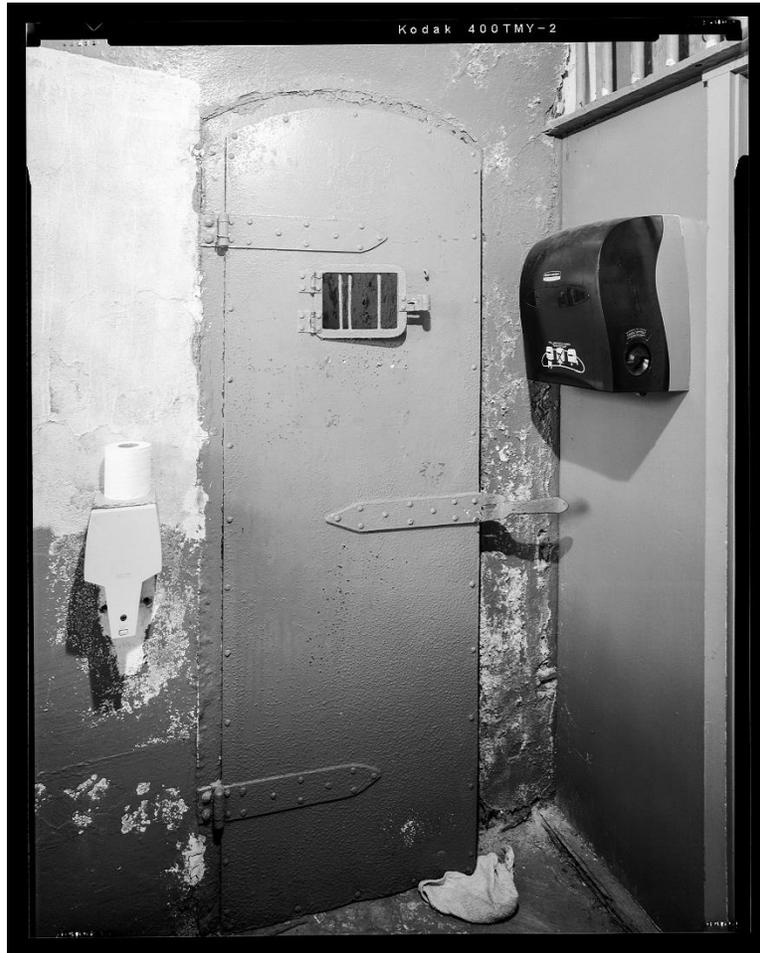
HABS No. HI-598-13

| HI-598-13 | Detail of door on first floor cell. View facing east. |

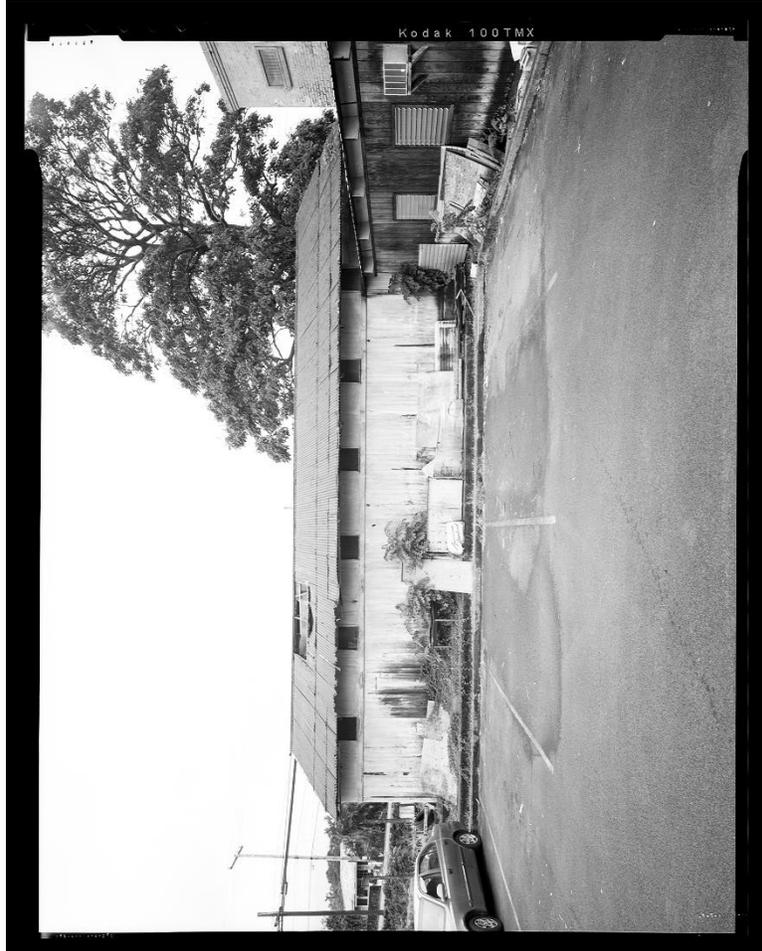
HABS No. HI-598-14

| HI-598-14 | Elevation of southeast side of wood cell block addition. View facing northwest. |

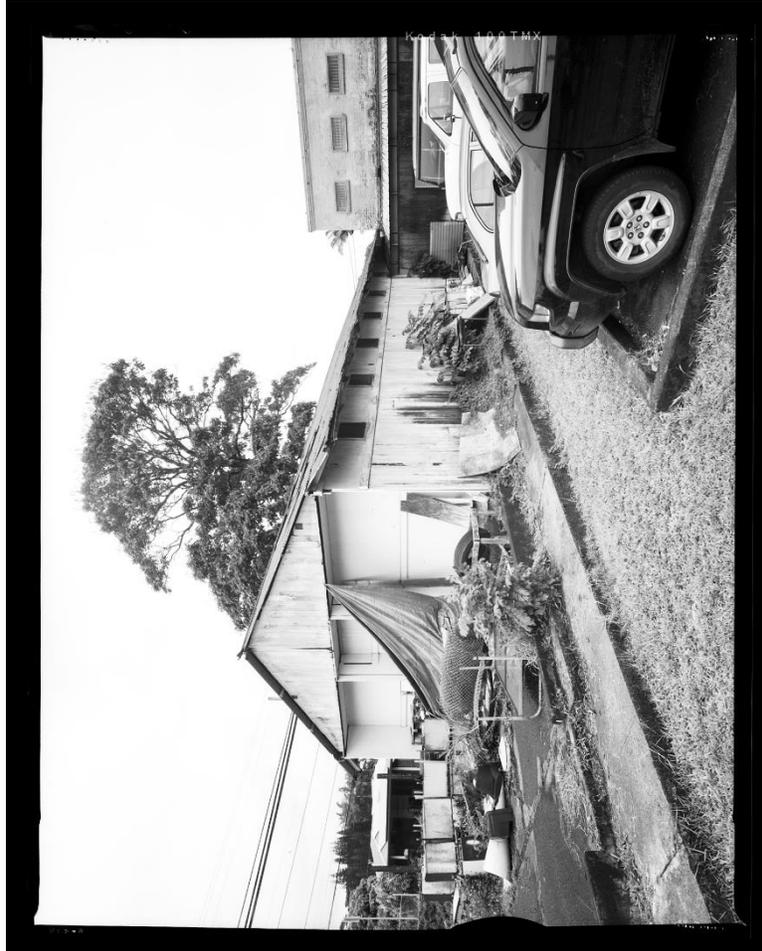
HABS No. HI-598-15

| HI-598-15 | Oblique of southwest end and southeast side of wood cell block addition. View facing north. |

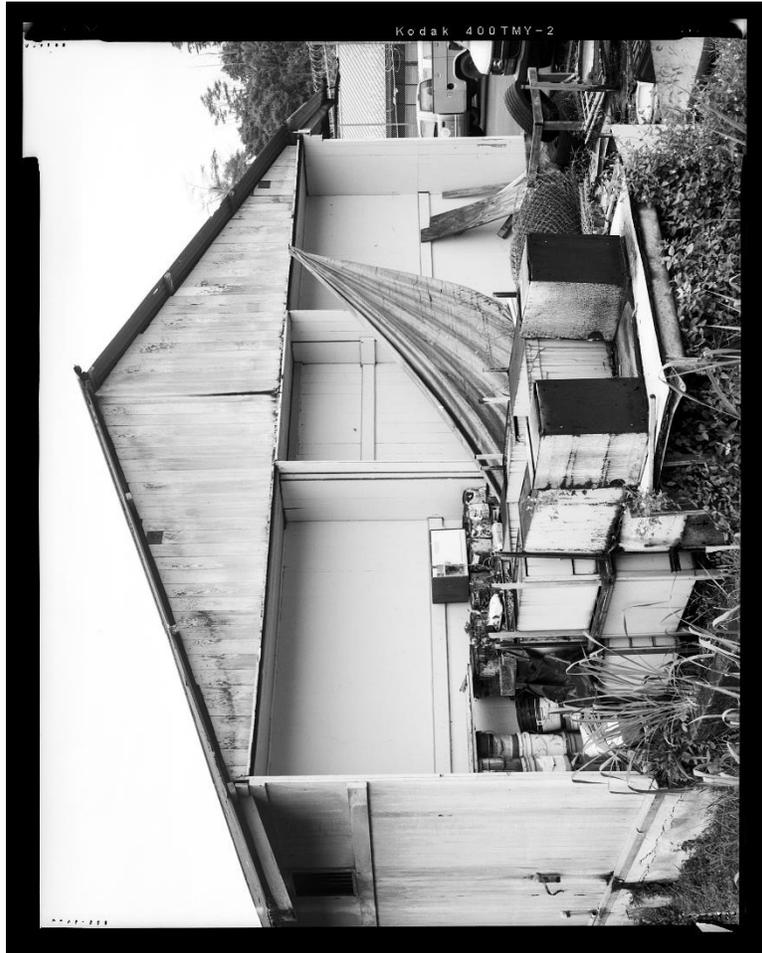
HABS No. HI-598-16

| HI-598-16 | Detail of truncated southwest end showing remnants of demolished portion of building. View facing east. |

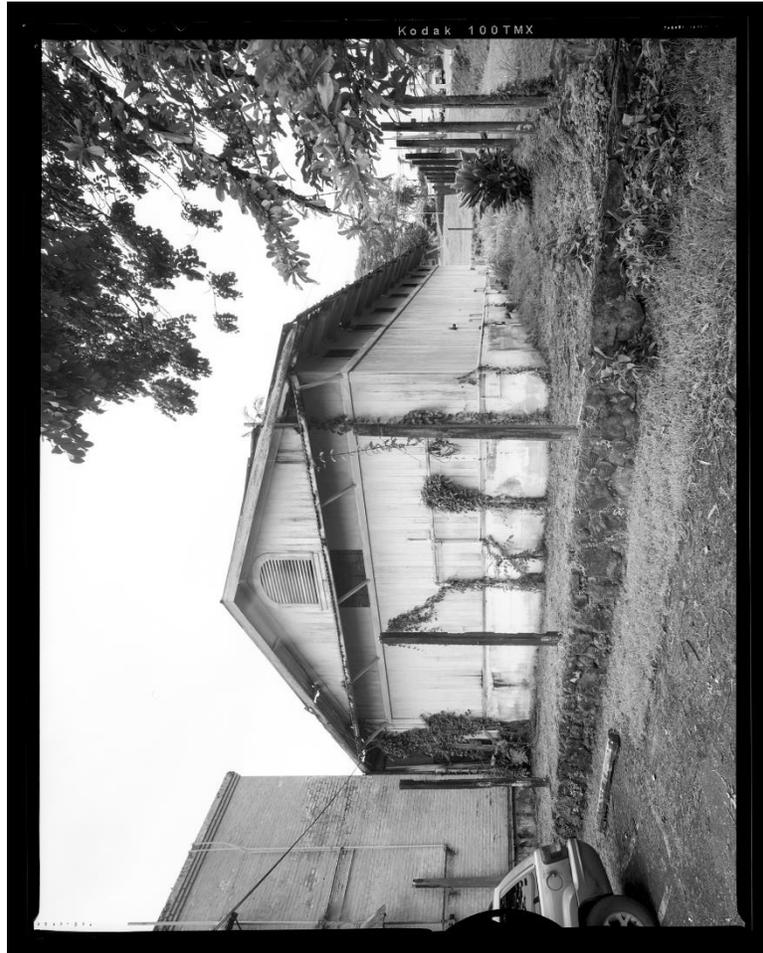
HABS No. HI-598-17

| HI-598-17 | Oblique of northeast end and northwest side of wood cell block addition. View facing south. |

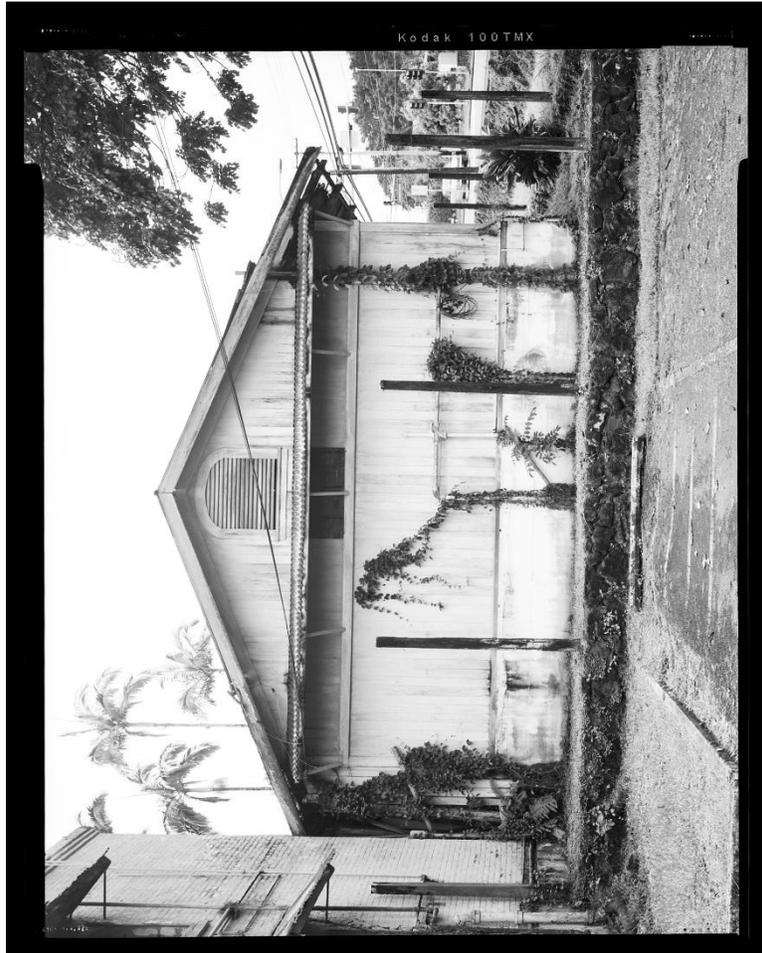
HABS No. HI-598-18

| HI-598-18 | Elevation of northeast end of wood cell block addition. View facing southwest. |

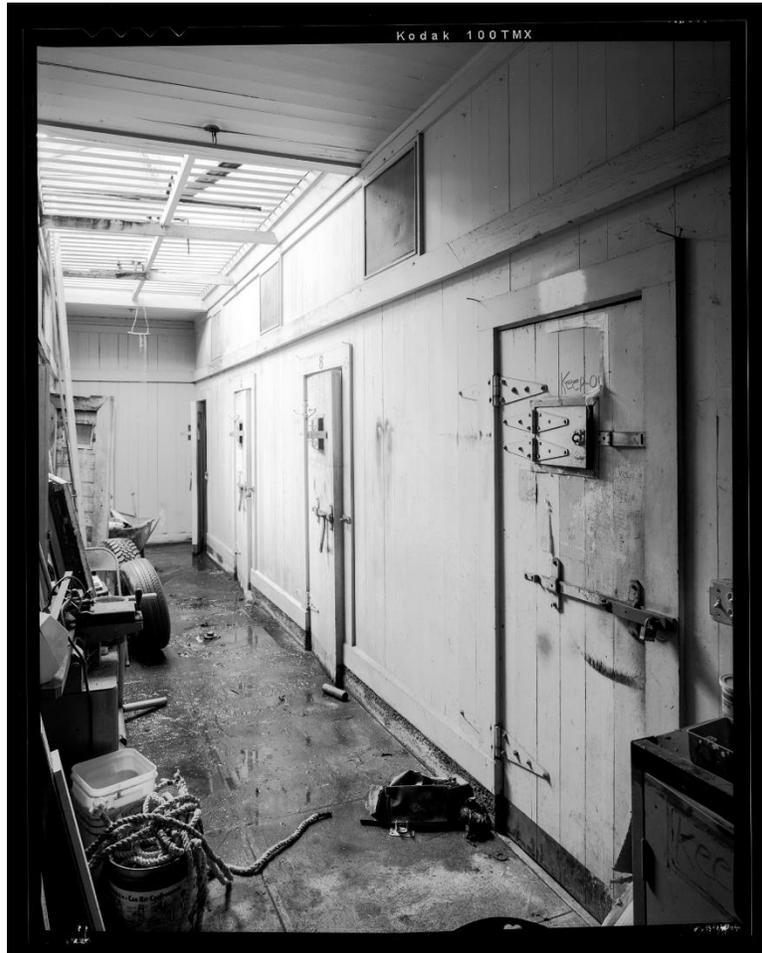
HABS No. HI-598-19

| HI-598-19 | Interior hall of wood cell block addition showing cell doors to the right. View facing south. |

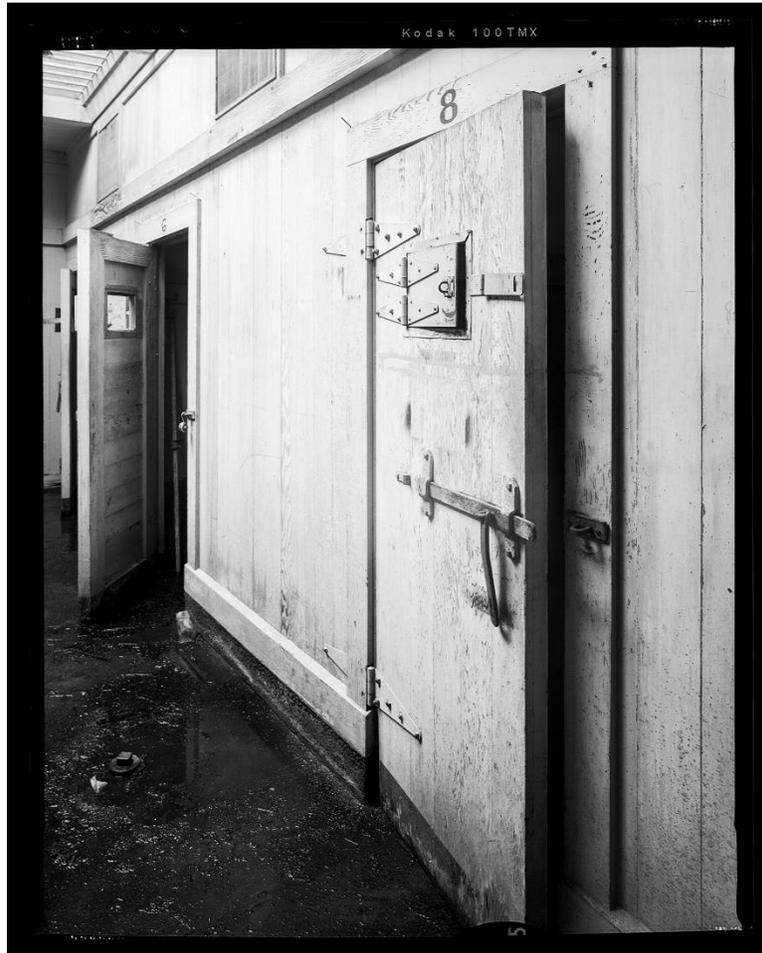
HABS No. HI-598-20

| HI-598-20 | Detail of wood cell door in wood cell block addition. View facing south. |
